**Flood Control Project Maintenance
Levee Inspections**

Fall 2008 Levee Maintenance Deficiency Summary Report

Reclamation District No. 0999

Levee Inspection Report By Mile - Fall 2008

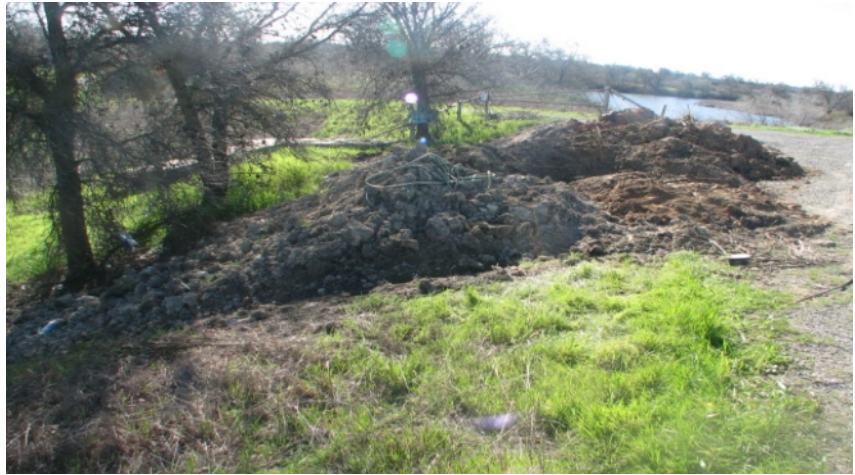
Levee Mile Report Line	4
Start Levee Mile	1.78
End Levee Mile	1.78
Location	
Category	Earthen Levee
Item	Encroachments
Material pile on waterside shoulder at LM 1.78

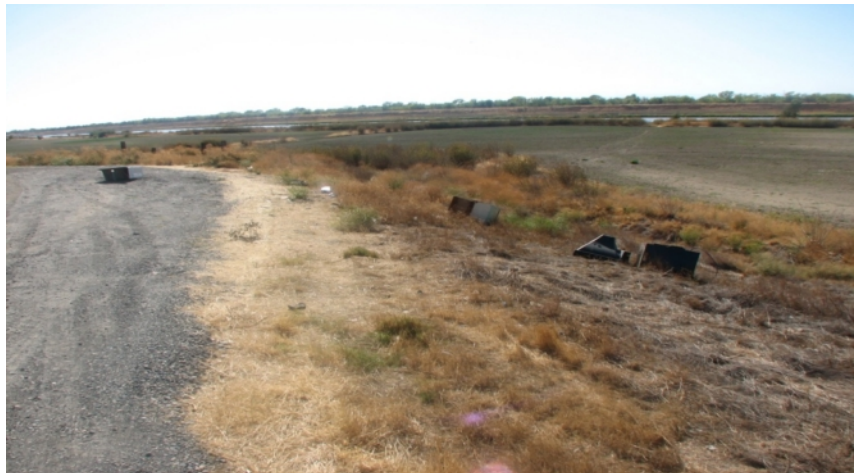
Levee Mile Report Line	11
Start Levee Mile	2.25
End Levee Mile	2.25
Location	
Category	Earthen Levee
Item	Encroachments
Garbage on waterside shoulder & slope

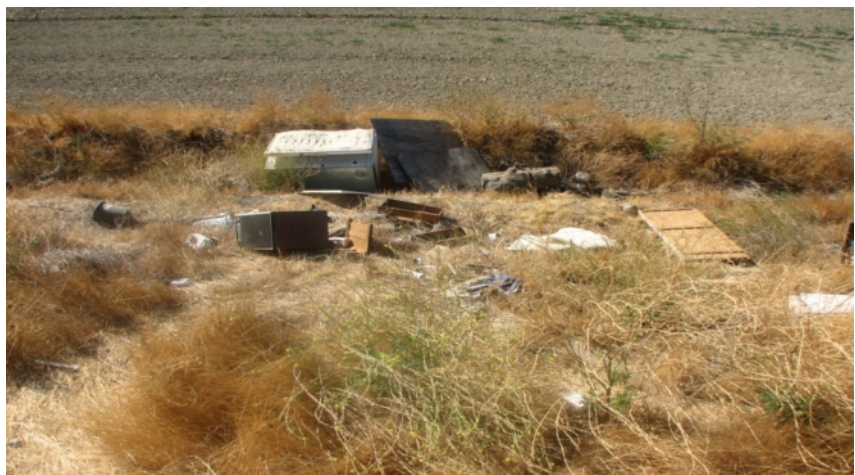
Levee Mile Report Line	13
Start Levee Mile	2.52
End Levee Mile	2.52
Location	
Category	Earthen Levee
Item	Encroachments
Garbage at waterside slope & toe.

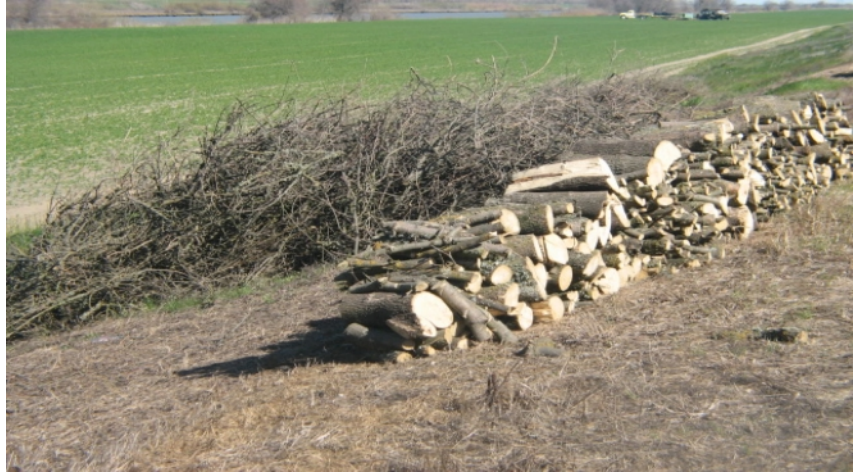
Levee Mile Report Line	17
Start Levee Mile	4.57
End Levee Mile	4.61
Location	
Category	Earthen Levee
Item	Encroachments
Pruning & Firewood pile along waterside shoulder and slope at LM 1.56

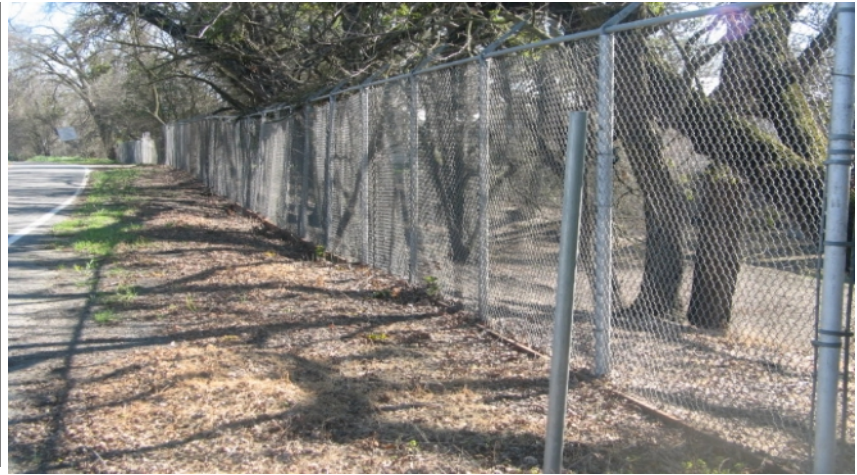
Levee Mile Report Line	3
Start Levee Mile	0.05
End Levee Mile	0.11
Location	
Category	Earthen Levee
Item	Encroachments
Cyclone fence along landside shoulder at LM 0.05 -0.11

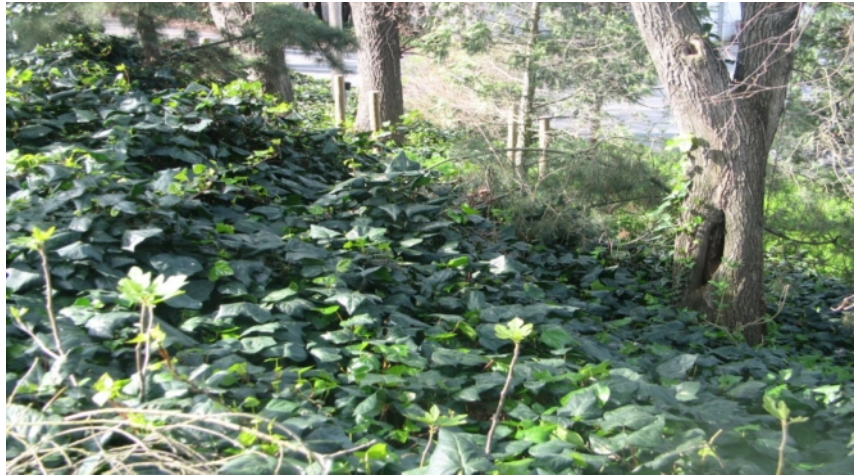
Levee Mile Report Line	9
Start Levee Mile	0.84
End Levee Mile	0.94
Location	
Category	Earthen Levee
Item	Encroachments
View of landscaping (Ivy) blocking view of landside slope from LM 0.84 to 0.94

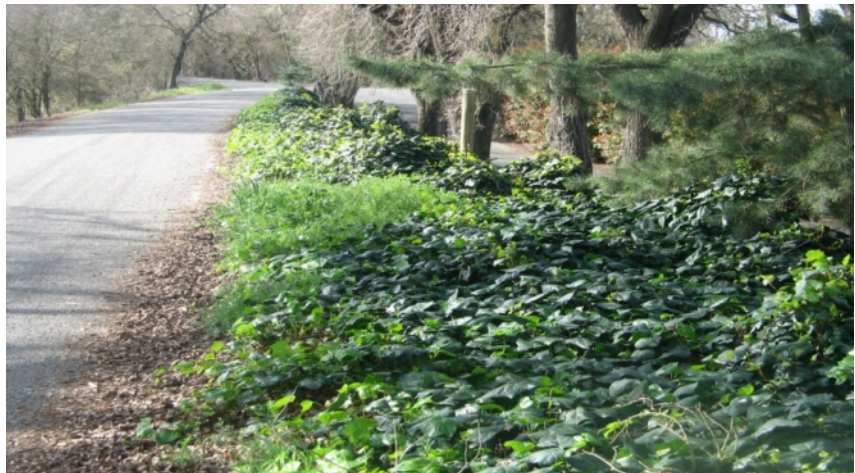
Levee Mile Report Line	9
Start Levee Mile	0.84
End Levee Mile	0.94
Location	
Category	Earthen Levee
Item	Encroachments
View of landscaping (Ivy) looking upstream from LM 0.84 to 0.94

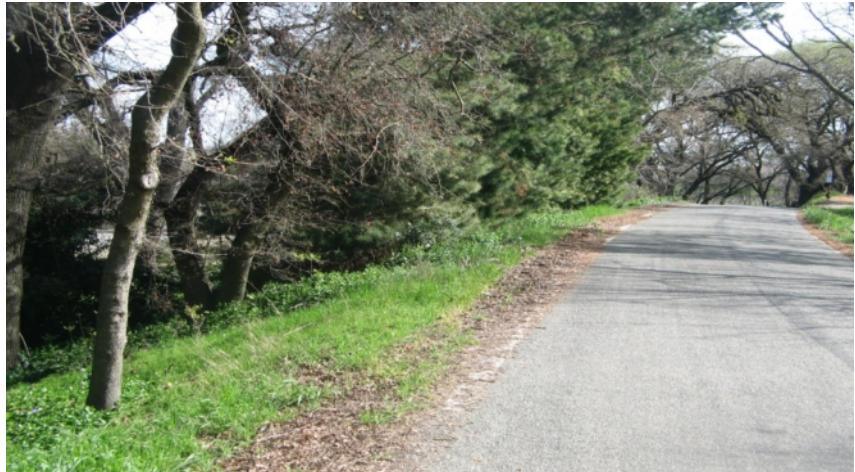
Levee Mile Report Line	35
Start Levee Mile	3.19
End Levee Mile	3.24
Location	
Category	Earthen Levee
Item	Encroachments
Looking downstream of landscaping blocking view of landside slope from LM 3.19 to 3.24

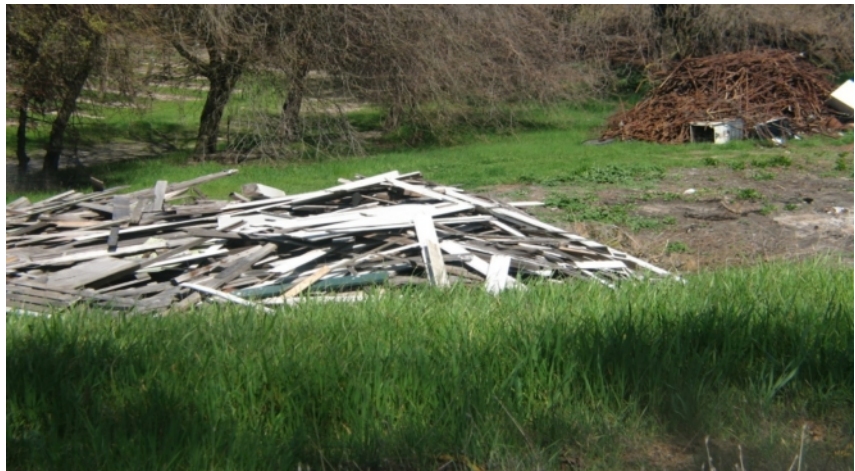
Levee Mile Report Line	46
Start Levee Mile	3.96
End Levee Mile	3.96
Location	
Category	Earthen Levee
Item	Encroachments
Garbage piles on landside toe at LM 3.96

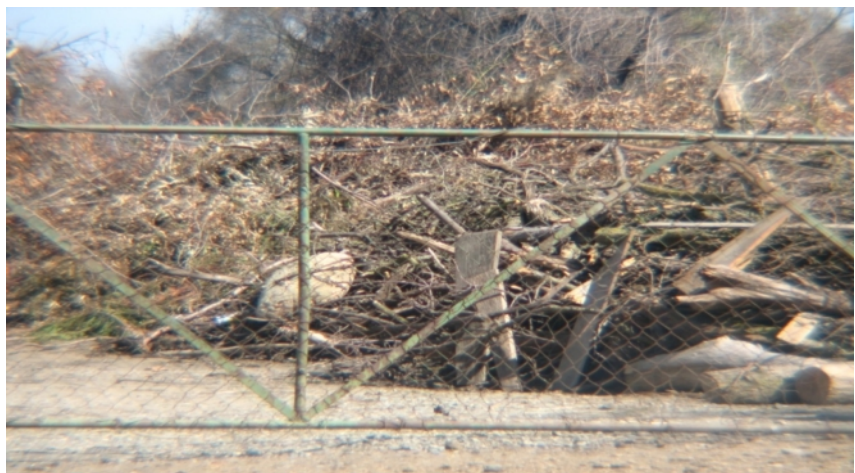
Levee Mile Report Line	51
Start Levee Mile	4.31
End Levee Mile	4.32
Location	
Category	Earthen Levee
Item	Encroachments
Pruning piles on waterward shoulder from LM 4.31 to 4.32

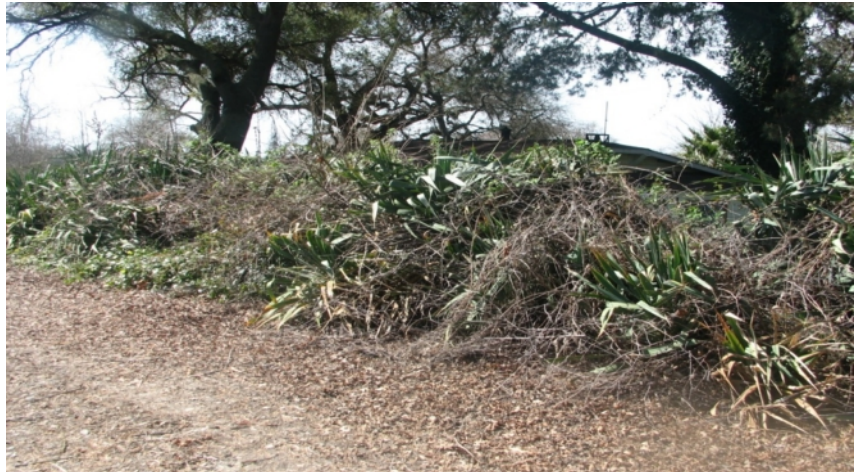
Levee Mile Report Line	52
Start Levee Mile	4.38
End Levee Mile	4.41
Location	
Category	Earthen Levee
Item	Encroachments
Overgrown landscaping on landside slope blocking view of slope from LM 4.38 to 4.41

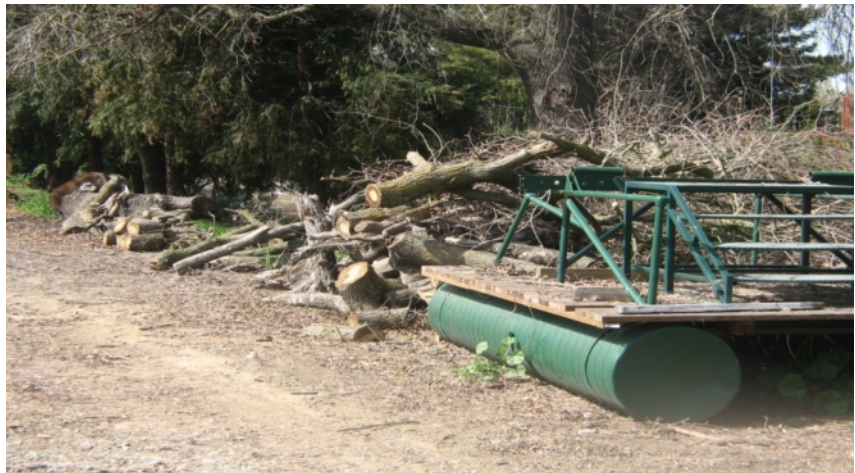
Levee Mile Report Line	59
Start Levee Mile	4.72
End Levee Mile	4.72
Location	
Category	Earthen Levee
Item	Encroachments
Prunings and firewood on landside shoulder at LM 4.72

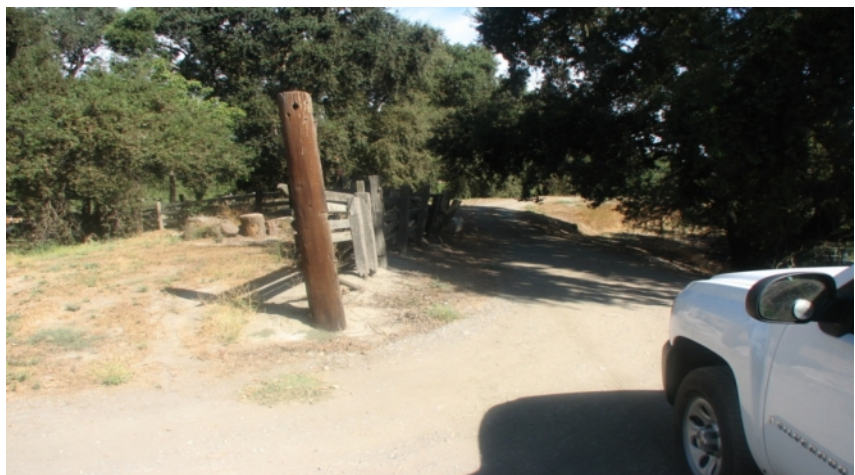
Levee Mile Report Line	78
Start Levee Mile	6.83
End Levee Mile	6.83
Location	
Category	Earthen Levee
Item	Encroachments
Fence and Firework at landside shoulder.

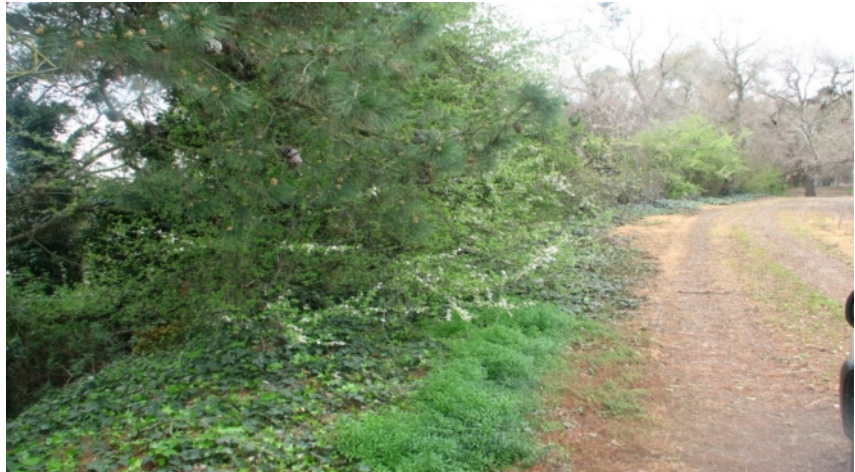
Levee Mile Report Line	84
Start Levee Mile	7.65
End Levee Mile	7.72
Location	
Category	Earthen Levee
Item	Encroachments
Landscaping on landside slope blocking view of slope from LM 7.65 to 7.72

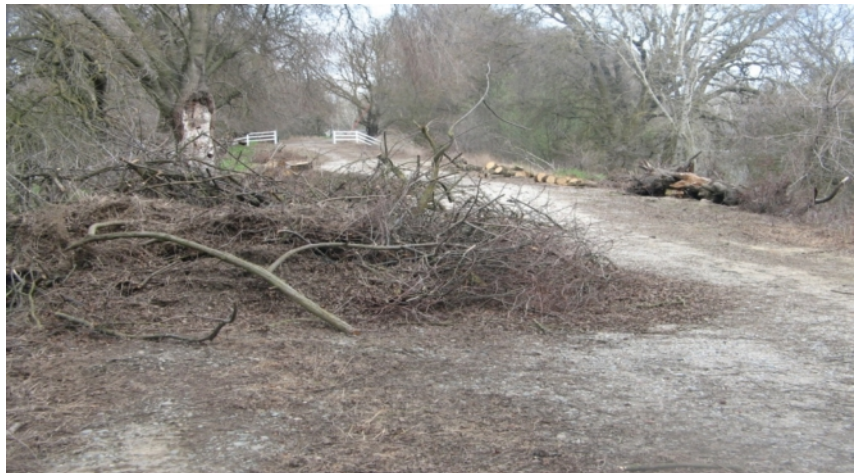
Levee Mile Report Line	90
Start Levee Mile	8.51
End Levee Mile	8.51
Location	
Category	Earthen Levee
Item	Encroachments
Prunings and firewood on waterside and landside shoulder at LM 8.51

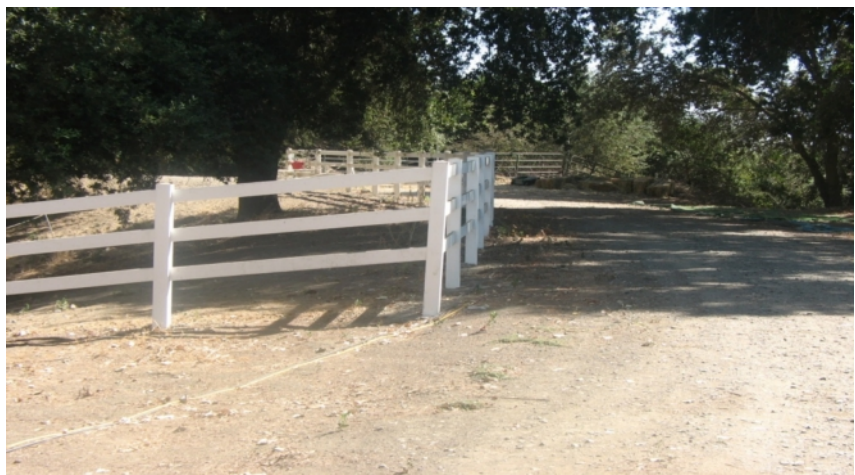
Levee Mile Report Line	91
Start Levee Mile	8.57
End Levee Mile	8.61
Location	
Category	Earthen Levee
Item	Encroachments
New installed unauthorized fence at landside slope and shoulder.

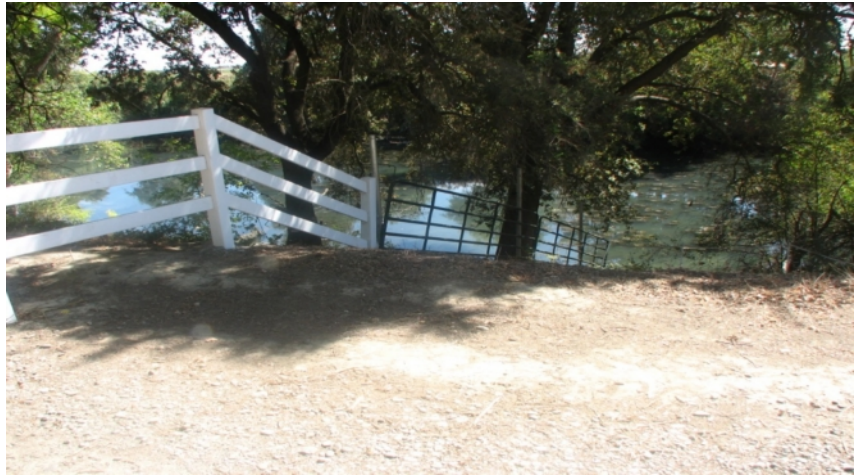
Levee Mile Report Line	94
Start Levee Mile	8.72
End Levee Mile	8.72
Location	
Category	Earthen Levee
Item	Encroachments
New unauthorized fence that extend from landside toe to waterside toe.

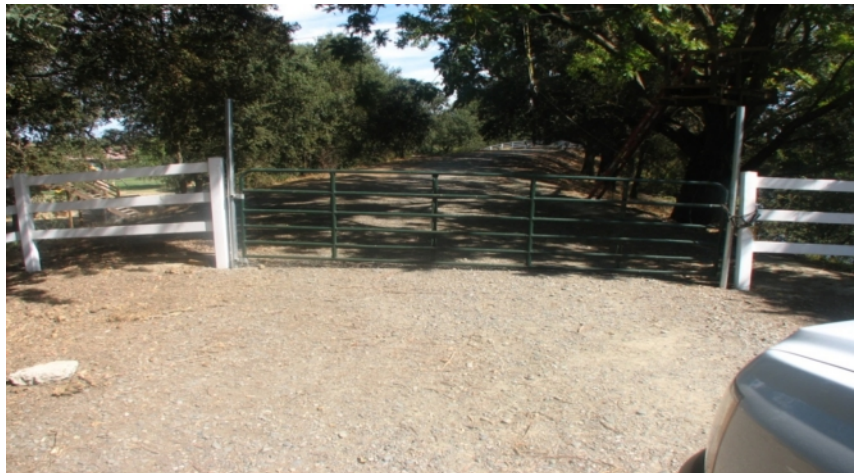
Levee Mile Report Line	94
Start Levee Mile	8.72
End Levee Mile	8.72
Location	
Category	Earthen Levee
Item	Encroachments
View of fence & gate across levee crown, landside & waterside slope.

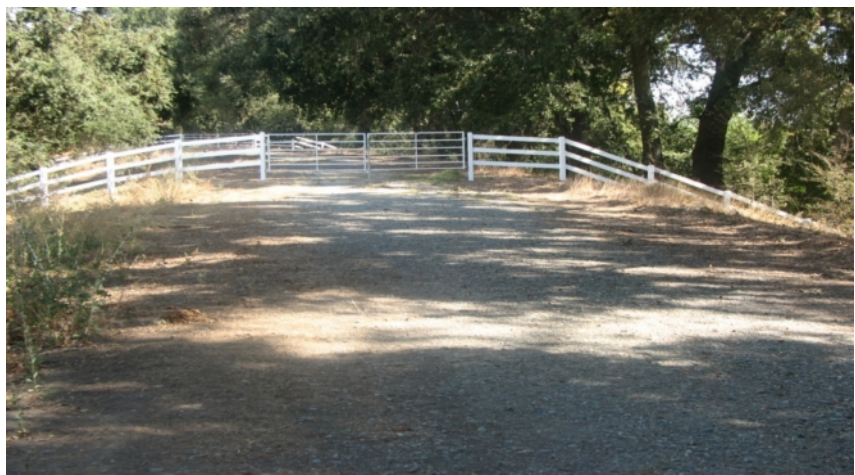
Levee Mile Report Line	95
Start Levee Mile	8.78
End Levee Mile	8.78
Location	
Category	Earthen Levee
Item	Encroachments
New unauthorized fence and gate that extend from landside toe across levee crown to waterside toe.

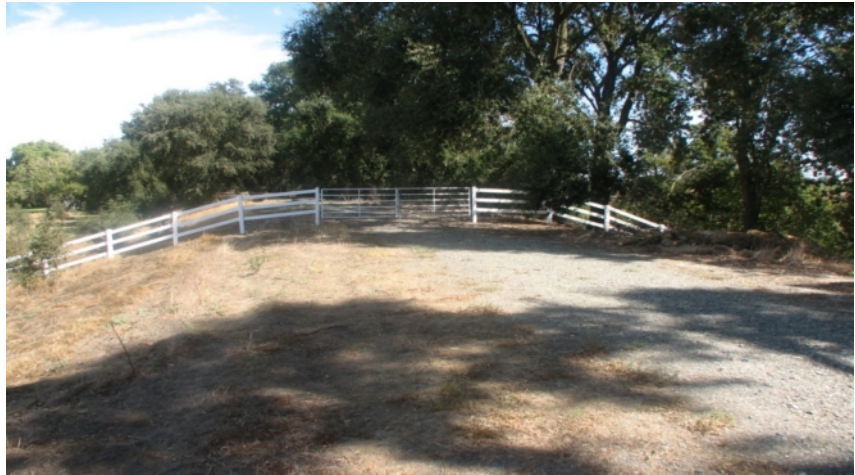
Levee Mile Report Line	97
Start Levee Mile	8.81
End Levee Mile	8.81
Location	
Category	Earthen Levee
Item	Encroachments
New unauthorized fence and gate that extend from landside toe across levee crown to waterside toe.
